Contract #: 04-0120F4Cty: SF/ALA Rte: 80 PM: 13.2/13.9File #: 1.28**WELDING INSPECTION REPORT****Resident Engineer:** Casey, William**Address:** 333 Burma Road**City:** Oakland, CA 94607**Report No:** WIR-029932**Date Inspected:** 22-Aug-2013**Project Name:** SAS Superstructure**OSM Arrival Time:** 700**Prime Contractor:** American Bridge/Fluor Enterprises, a JV**OSM Departure Time:** 1730**Contractor:** American Bridge/Fluor Enterprises, a JV**Location:** Job Site**CWI Name:** Bernie Docena, Jesse Cayabyab**CWI Present:** Yes No**Inspected CWI report:** Yes No N/A**Rod Oven in Use:** Yes No N/A**Electrode to specification:** Yes No N/A**Weld Procedures Followed:** Yes No N/A**Qualified Welders:** Yes No N/A**Verified Joint Fit-up:** Yes No N/A**Approved Drawings:** Yes No N/A**Approved WPS:** Yes No N/A**Delayed / Cancelled:** Yes No N/A**Bridge No:** 34-0006**Component:** SAS Tower**Summary of Items Observed:**

ESW Repair excavation

RWR-201308-004

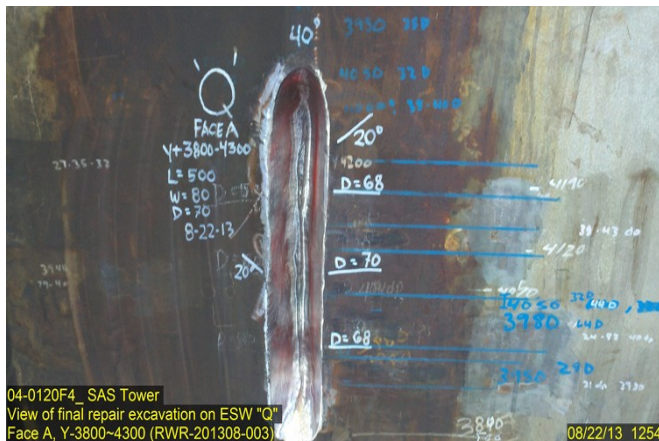
The QA Inspector observed ABF welder Donald Plumb (WID-0891) performing excavation of ESW "Q" Face A @ Y-3980mm to verify indications observed during Ultrasonic Testing pulse/echo & pitch/catch. Mr. Plumb was performing the excavation using an air carbon arc gouging and a grinder. The repair previously commenced on 8-21-13. Location of the repair excavation is as follows:

Weld excavated at 74mm dp- No indications observed.

Final excavation: Y=3800mm~4300mm, L=500mm, W=80mm, D=70mm

After grinding to bright metal the ABF QC Inspector Bernie Docena performed MT testing of the excavation. The QC Inspector stated the excavation appears to be free of discontinuities and he would complete ABF daily inspection report and magnetic particle testing report to detail the findings. The QA Inspector also performed MT inspection of the final excavation. After excavation Mr. Plumb was observed setting up to perform SMAW repair welding on this date. See TL-6028 for additional details on items inspected on this date.
